Argent House - Leaking Storm Water Line

Location: Argent House, Cnr of Love Day & Kay st, Johannesburg, South Africa

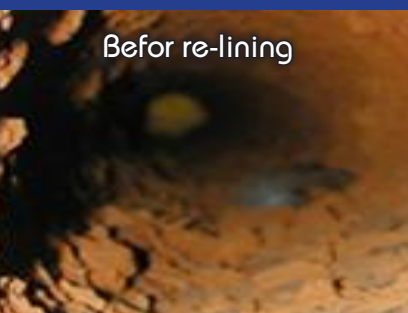
Nu Flow traced the leak to a storm water line.

Before re-lining

Nu Flow then relined the storm water line and a gully with a 4" Nu Flow epoxy structural liner. The problem was solved without any digging, chopping or any disruption to the daily working operations of the building and staff despite the pipe containing multiple bends.

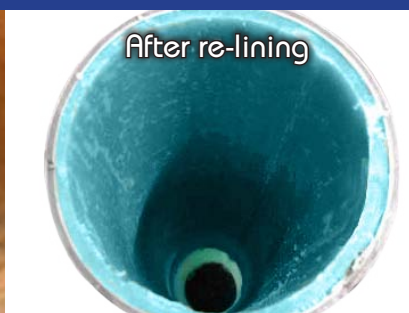
After re-lining

The end result is a new pipe within the old pipe.
 No Mess, no chopping open, no damage to structures!
