Bulwer rd, Glenwood - Sewer Pipe

Location: Bulwer rd, Glenwood, Kwazulu Natal, South Africa.

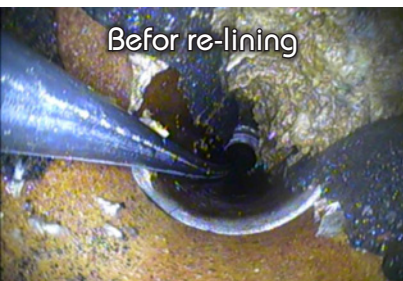
The client complained of continuous sewer blockages on the main 110mm Clay/PVC line that runs under paving 2.5 meters deep at the pool area. Ganga Plumbers, a new flow licensee, was called and camera surveyed the line. They identified three large breaks on the line, one of which the pipe was dismembered causing the continuous blockage. This pipe is a clay pipe and has multiple PVC joints. All of the clay pipe was badly cracked causing continual blockages.

Before re-lining

Ganga Plumbers, a new flow licensee, first cleaned the 110mm clay/PVC sewer line using a high pressure jetting unit. Ganga Plumbers re-surveyed the line to identify the exact problem areas. They then used a pull-in-place structural liner to re-line the pipe. The dismembered pipe was linked using the epoxy liner and created one continuous pipe.

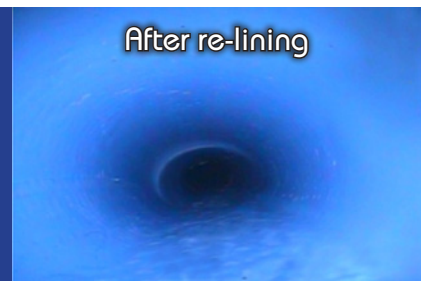
After re-lining
