## Nu Flow re-lines pipes at home in Sandhurst

**Location:** Empire rd, Sandhurst, Gauteng

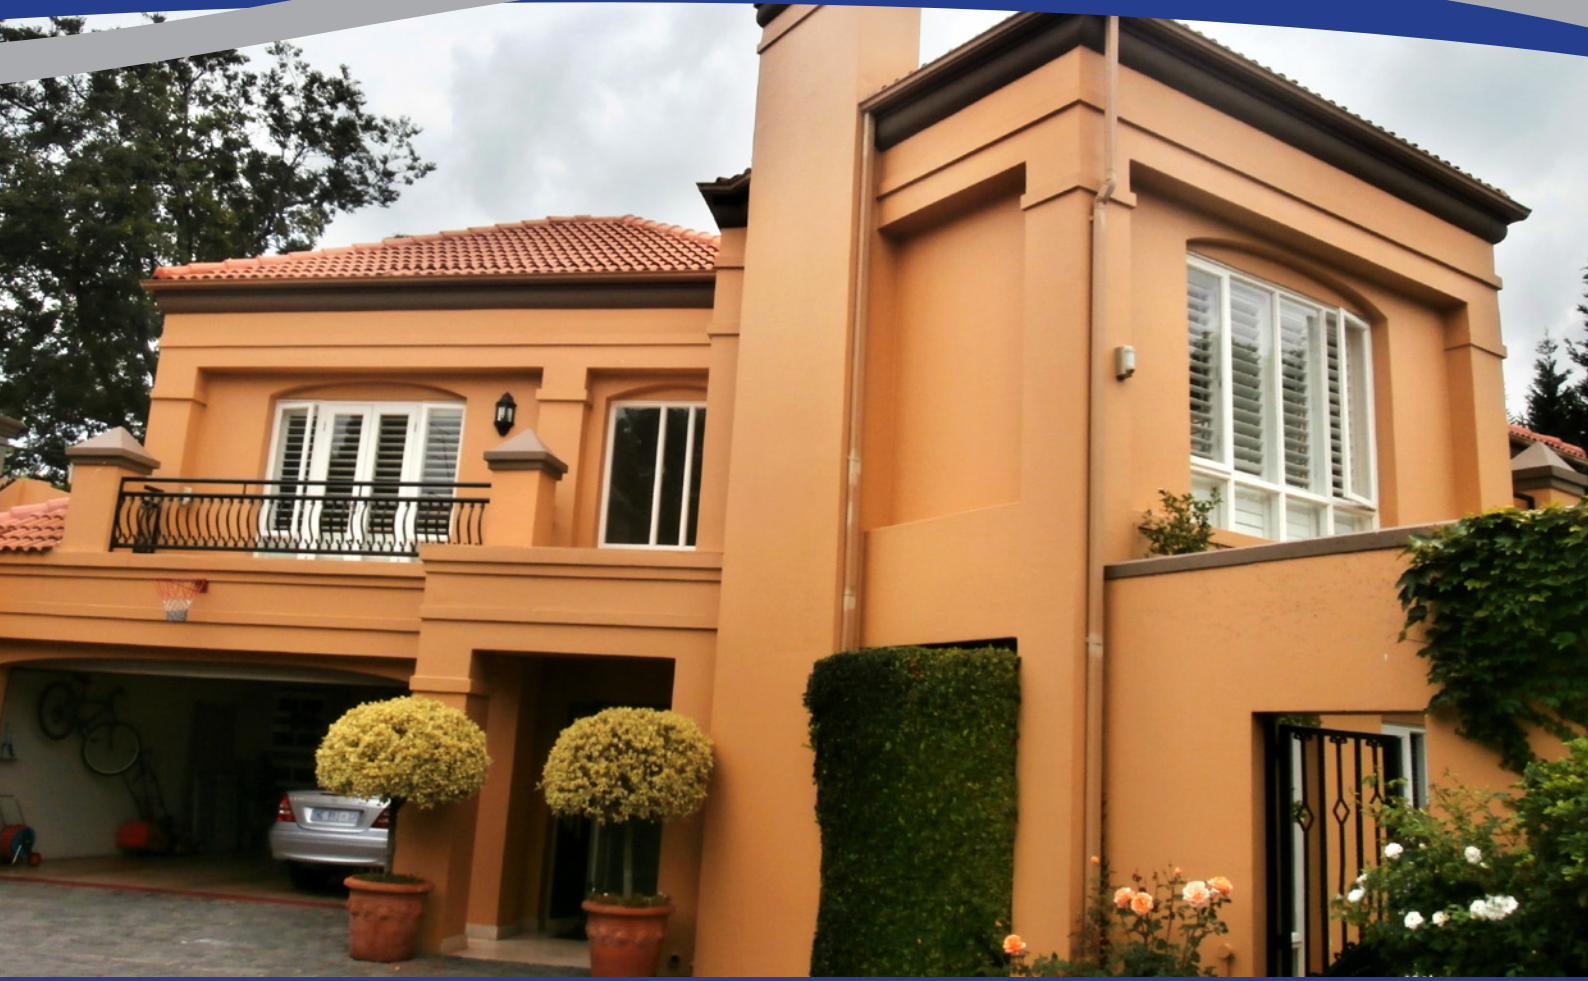
The home in Sandhurst was experiencing water damage in the roof slab above the lounge due to two leaking points in a PVC pipe running from one of the upstairs toilets.

The home owner called in a plumber who used a sealant to seal the two leaking points, but the problem continued.

Nu Flow used a CCTV camera to locate and analyse the two leaking points in the pipe. Nu Flow then used a pull-in-place structural liner to re-line the pipe working from existing access points and therefore caused absolutely NO damage to the structural integrity of the home.

The end result is a new pipe with-in the original pipe.
