Nu Flow re-lines home in Midrand

Location: Midrand, Gauteng

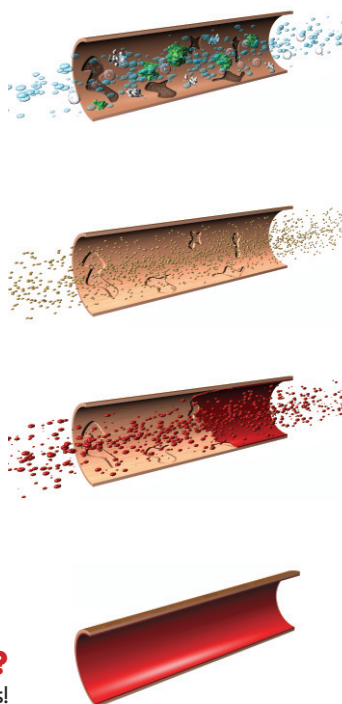
Situation: A leak detector was called to the house to find a leak that was causing damp in the walls of the home. The house was done with the composite pipes.

Are you concerned about elbows & tees in pipes?
Nu Flow re-lining process can effortlessly get around 90 degree bends!

Solution: Mobile Leak Detection, a Nu Flow licensee used Nu Flow epoxy coating to re-line the entire bathroom's pipes working from existing access points.

After the pipes had been re-lined the damp problem stopped. The end result is a re-lined pipe repaired from the inside.
