## Atholl - Leaking Drain Pipe

**Location:** Atholl, Gauteng Province, South Africa

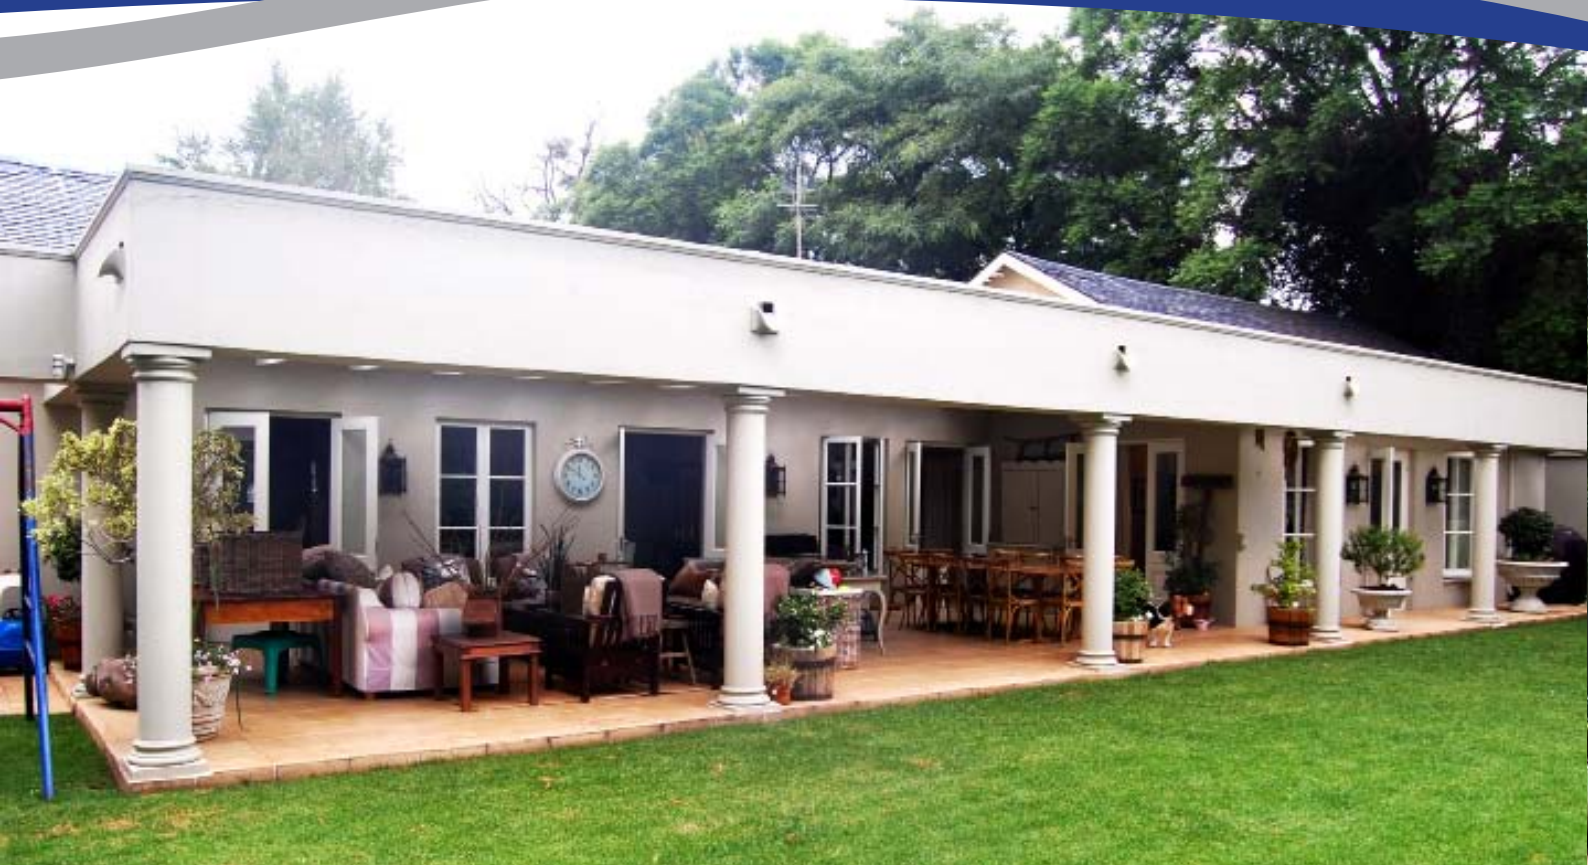
The home had a 110mm PVC and earthenware drain pipe that was badly damaged which caused the pipe to experience continual blockages. The drain pipe ran under the house and replacing the pipe would mean chopping open the kitchen floor and beautifully landscaped garden at an estimated cost of R100,000.00

Nu Flow South Africa used pull in place structural liners to re-line the damaged pipe a without having to break through the kitchen floor and garden.

The end result is a new pipe with in the old pipe.
