Blue Hills Country Estate - Leaking Drain Stacks

Location: Blue Hills Country Estate, Gauteng Province, South Africa

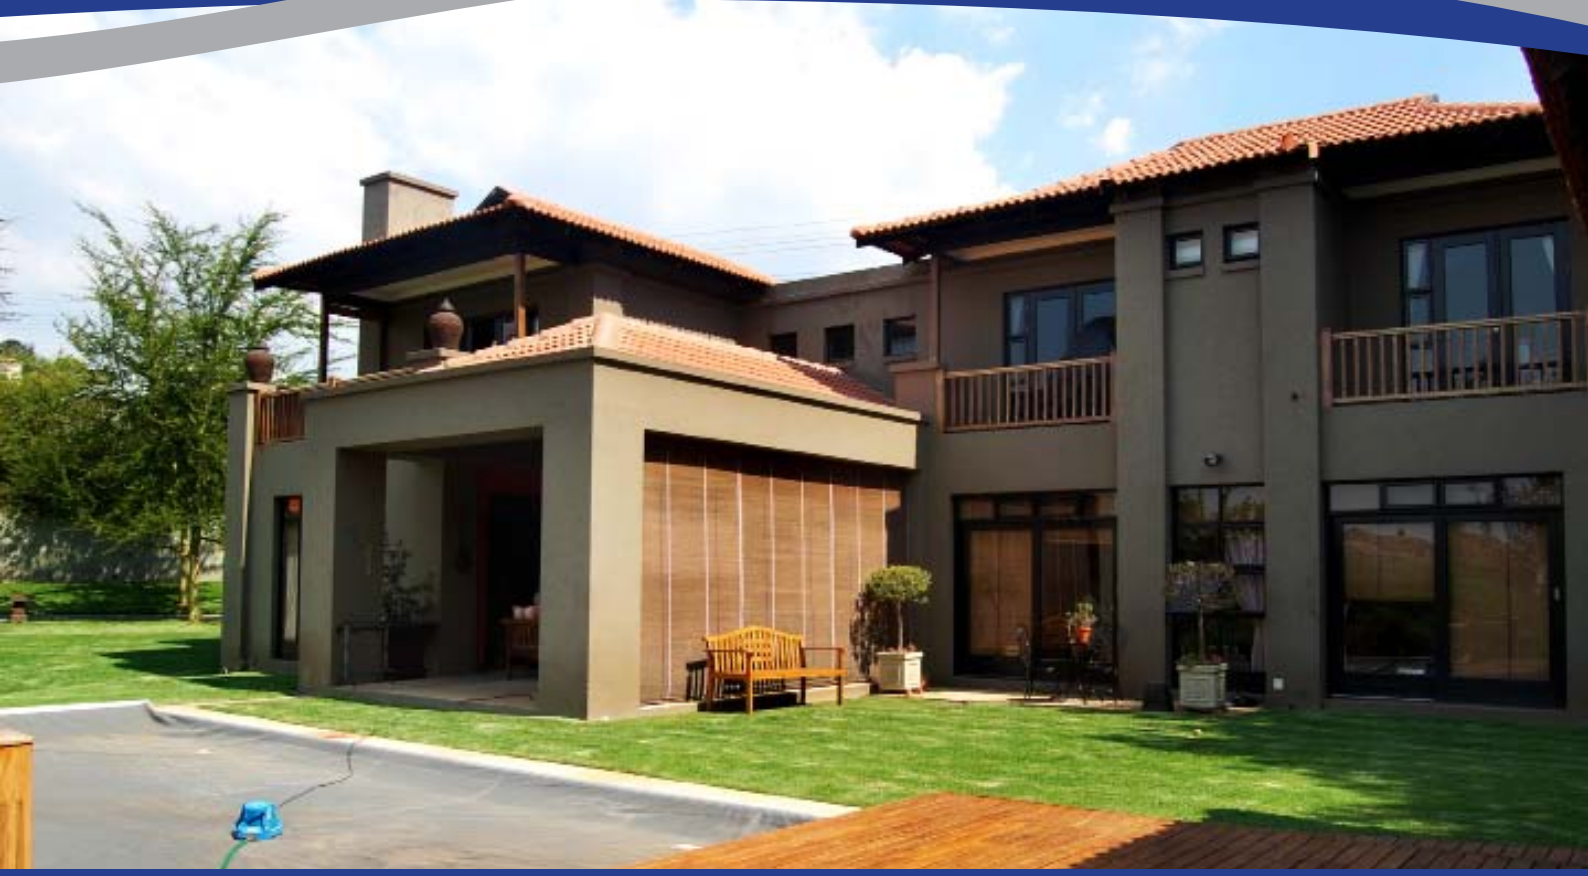
The home had three 100mm PVC drain stacks that were leaking due to nails been hammered into the wall columns which punctured the pipes. The leaking pipes caused major water damage to both the inside and outside walls of the house.

Nu Flow South Africa used structural liners to reline the leaking pipe with out having to break through the wall columns or beautifully tiled bathroom wall and floors despite the pipe containing 90° bends.

The residents of the house were able to continue with their daily activities while the pipes were being relined. The end result is a new pipe with in the old pipe
