First National Battery - Damaged Sewer Line

Location: First National Battery, Benoni, Gauteng, South Africa

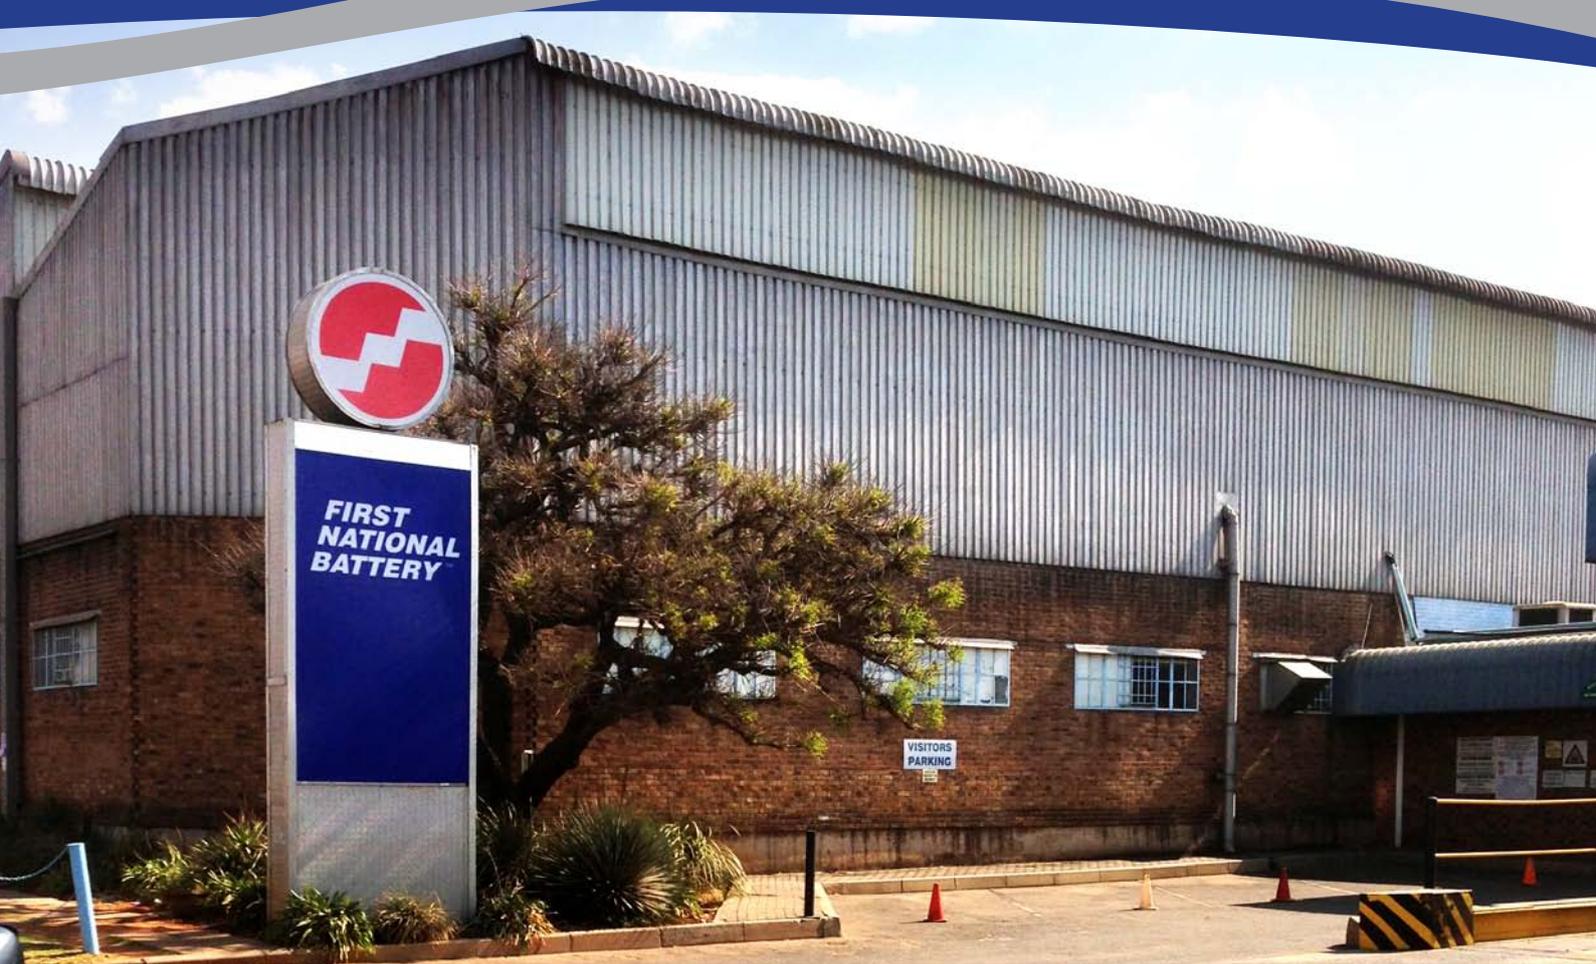
Situation: First National Battery had a problem with their sewer line which was built over and now runs under the building. The man hole is now also under the building with an entrance for access to the manhole which makes working in the manhole very unsafe and unpredictable.

After a hole of 2m x 3m x 2m deep was excavated they got to the 110mm earthenware pipe and saw that it was much deeper than the man hole and therefore there had to be a ramp which complicated the issue even more.

Solution: Nu Flow South Africa first assessed the pipe with CCTV pipe inspection camera and saw it was earthenware pipe which had collapsed in numerous places throughout the length of the pipe running under the building.

Nu Flow reformed the broken pipe then pulled a Nu Flow structural liner in place relining the broken pipe. The customer was left with a brand new pipe with in the old broken earthenware pipe eliminating the dangerous manhole without any additional excavating. What a job!!
