Nu Flow re-lines at Tygerberg hospital

Location: Tygerberg hospital, Stellenbosch university student department, Cape Town

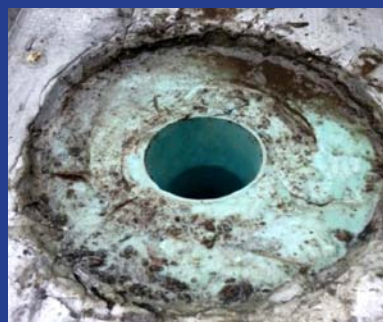
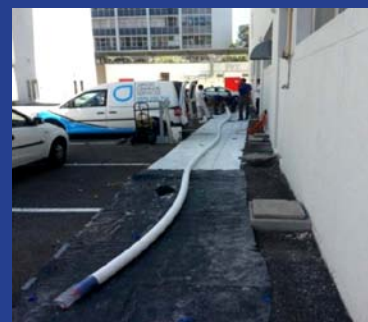
Tygerberg medical museum had four 100mm cast iron storm water lines which were heavily corroded with disjointed pipe work causing the museum to flood every time it rains.

The result is a new pipe where there was no pipe bridging the gaps in the pipe work where water constantly penetrated the building.

Water Damage Services, a Nu Flow licensee re-lined the full bores on the roof causing absolutely no down time to any of the departments ensuring daily operations remained on track.
