Nu Flow re-lines deteriorated sewer line at Westgate Shopping Centre

Location: Westgate, Roodepoort, Gauteng

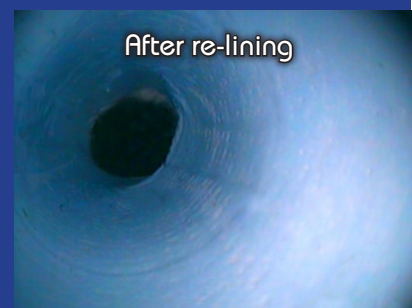
After re-lining

Solution: Watertight Leak Detection decided to use the Nu Flow technology and re-line a section of the pipe in question in a blue epoxy structural liner which was pulled in place through the existing rodding eyes and manholes avoiding extensive excavating and inconvenience to the centre, staff and key tenants.

The end result is a "nu pipe" with in the old pipe.
No Mess, no chopping open, no damage to structures!
