## Nu Flow stops bore hole contamination

Municipal Sewer line in Meyerton.

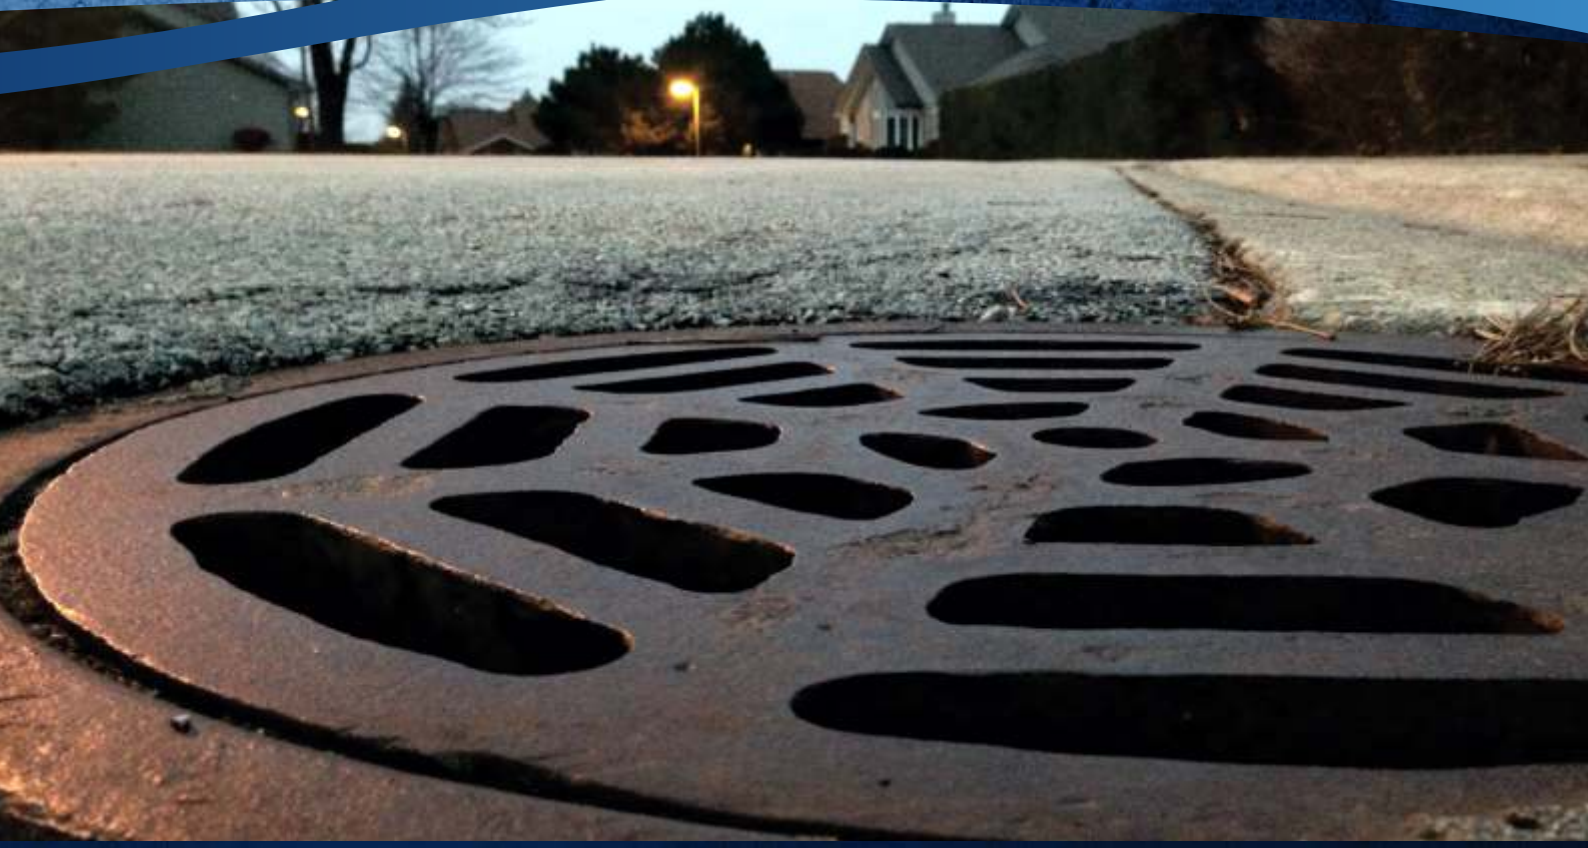
Nu Flow were called to reline a problematic municipal sewer line. The old cracked 160mm earthenware sewer line was leeching sewerage into the ground which was contaminating one of the residents boreholes.

The pipe runs from inside a golf course to the main municipal sewer line, but runs under the residential property with the affected borehole.

Nu Flow relined the sewer pipe with a structural liner working from two manholes as access points and thereby not needing to dig or excavate at all.

An epoxy saturated liner is pulled into the pipe. Within the liner is an inflatable bladder. When the liner is in the correct position, the bladder is inflated and left inflated while the epoxy cures.

Once the epoxy has cured, the bladder is removed leaving behind a structural "nu pipe" within the old pipe.
