## A salt water solution

**Site:** Dairy farm and residential estate in Jeffery's Bay

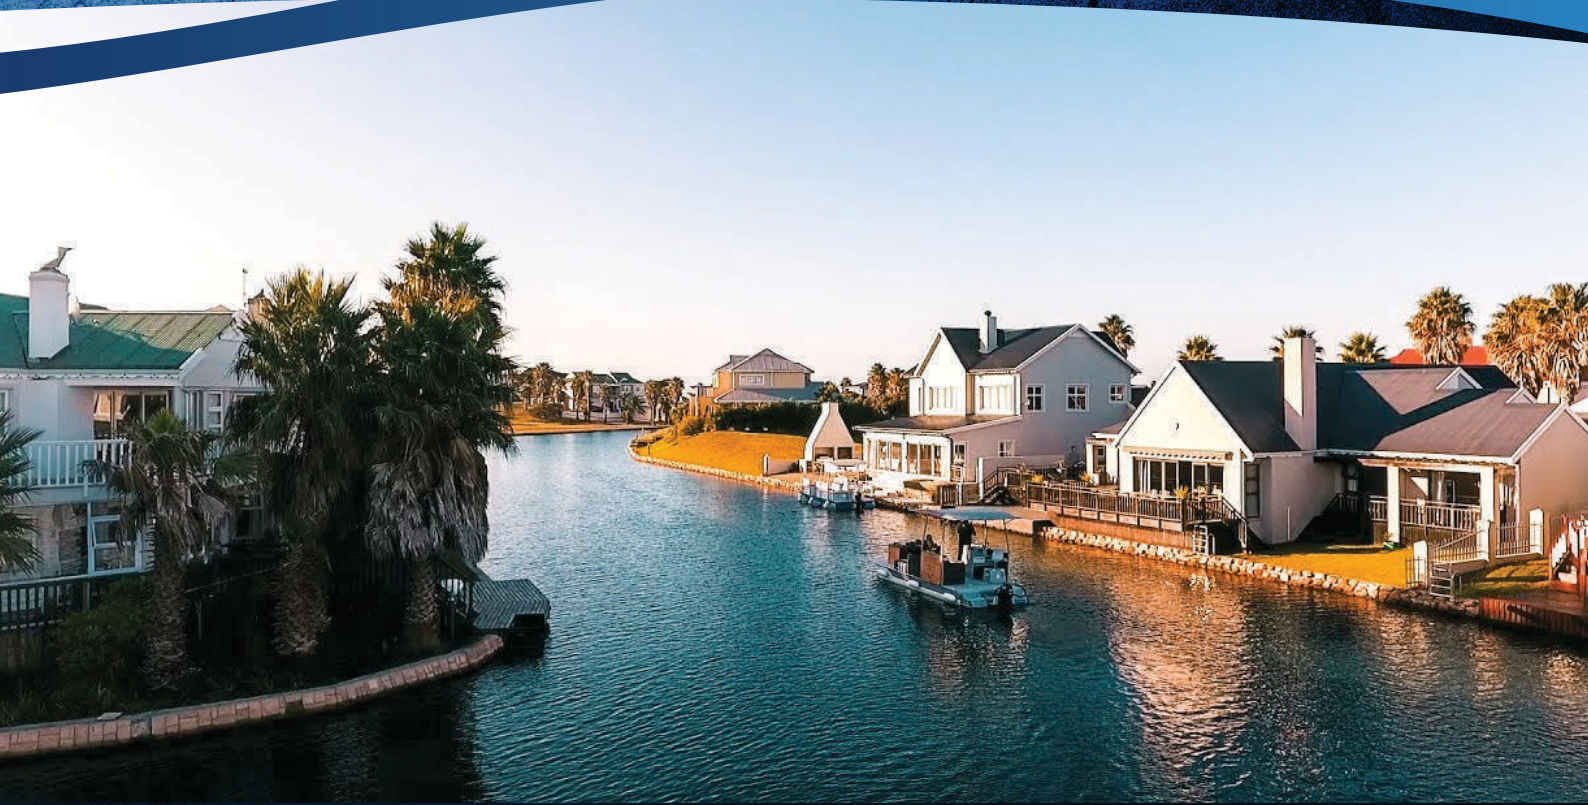
Nu Flow were called to camera inspect the pipes supplying the water to the farm. The pipes supplying the farmer with the water run under canals in a residential complex right on the beach. The CCTV camera inspection revealed that the pipes had leaking joints allowing sea water to leech into the pipes and contaminate the water.

**Solution:** The Farmer and Home Owners Association opted for the pipe to be relined with Nu Flow structural liners to seal all the joints and leaks and stop the sea water leaching into the pipe line.

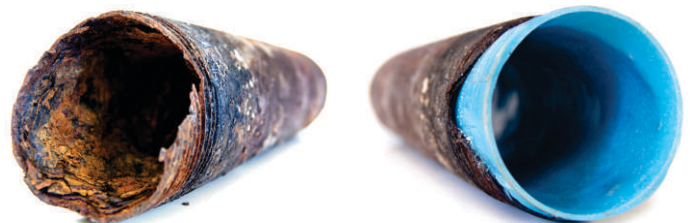
The pipes were cleaned using high pressure jetting. Once the pipe is clean, an epoxy saturated liner is pulled into the pipe.

Within the liner is an inflatable bladder.

When the liner is in the correct position the bladder is inflated and left inflated until the epoxy has cured.

Once the epoxy has hardened the bladder is removed leaving behind a "nu pipe" within the host pipe.
