**KEEP IT  
COOL!**

## Chiller pipe renewal at Southern Sun - Elangeni & Maharani

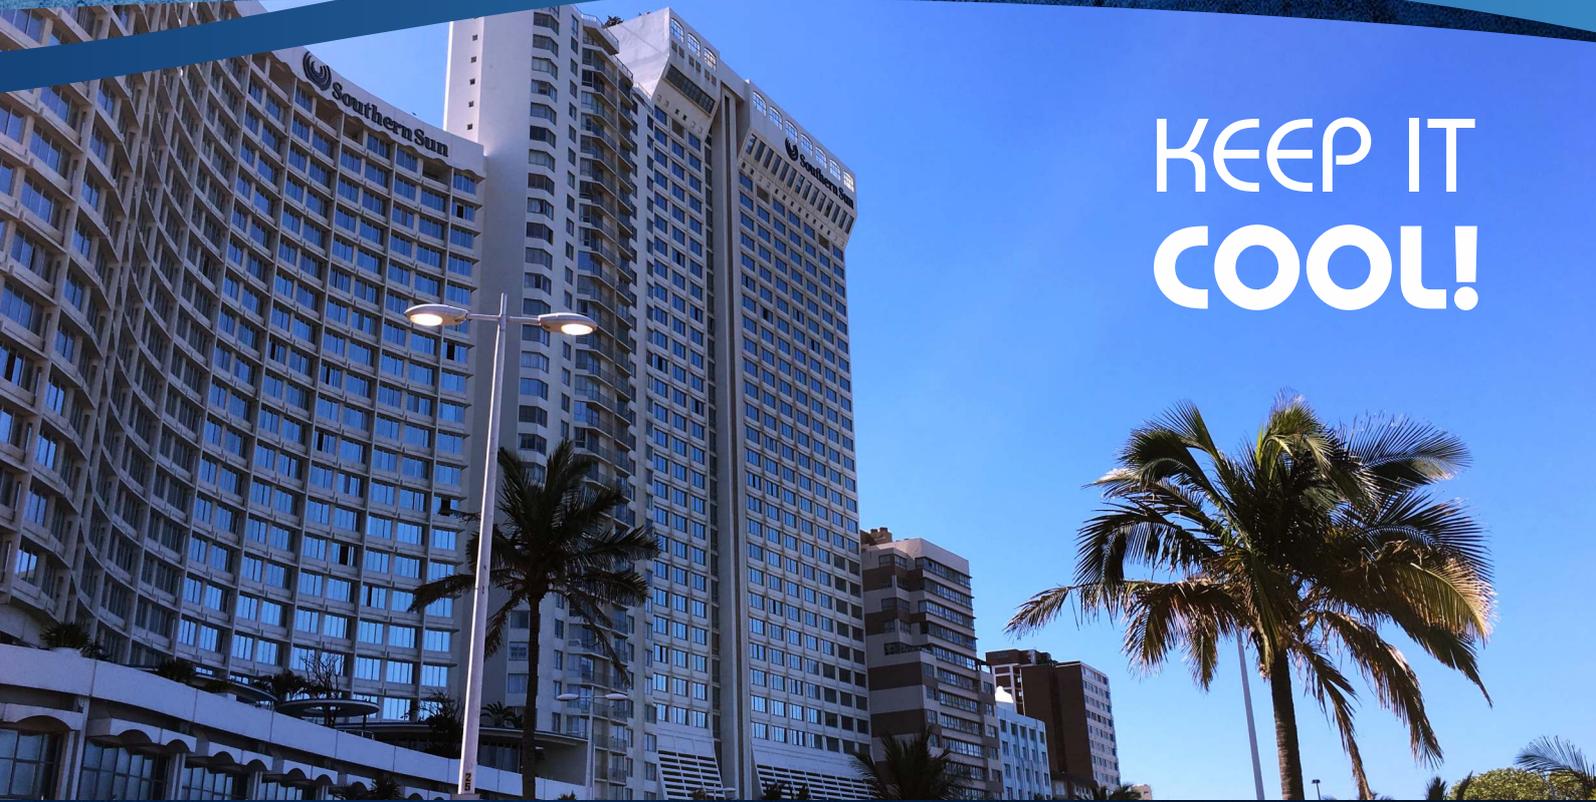
Nu Flow were called to repair two 210mm steel chiller pipes which were leaking into the hotel.

One pipe carries water from a pump room in the basement to the top of the 120 meter high building and the second pipe carries water back down to the pump room passing through the floor slabs on all 36 floors of the building.

The chiller pipes were leaking in a few places and were decommissioned. The Hotel wanted the chiller pipes repairs urgently with as little disruption as possible, especially as this was over the December holiday period where the hotel operates at maximum capacity.

The two chiller pipes were lined from top to bottom using Nu Flow's structural lining technology to create a new pipe within the host pipe.

The pipe was disconnected at the top and bottom of the building. The pipes were then descaled and cleaned using a pneumatic driven cleaning head and Renssi pipe cleaning chains with tungsten carbide tips which aggressively descale steel pipes.

Epoxy impregnated liners were then lowered down the pipes from the top of the building into the correct position. Within the liners is an inflatable bladder. When the liners are in position the bladder is inflated and left inflated until the epoxy has cured. The bladder is then removed leaving behind a "nu pipe" within the original corroded host pipe.
