Nu Flow re-lines home in Midrand

Location: Midrand, Gauteng

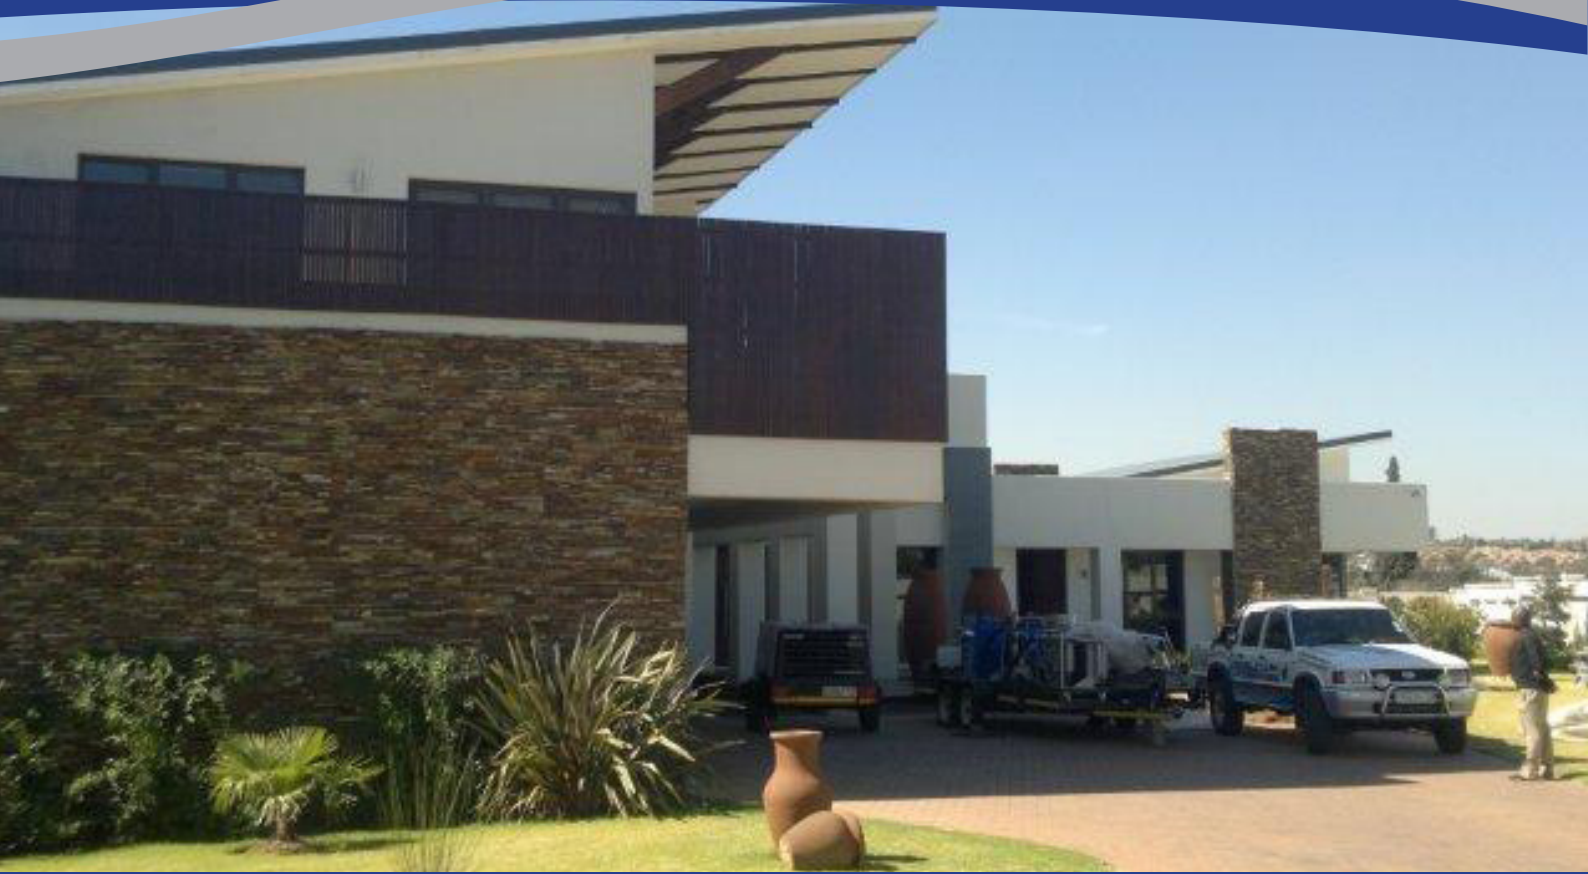
Situation: A leak detector was called to the house to find a leak that was causing damp in the walls of the home. The house was done with the composite pipes.

Solution: Mobile Leak Detection, a Nu Flow licensee used Nu Flow epoxy coating to re-line the entire bathroom's pipes working from existing access points.

After the pipes had been re-lined the damp problem stopped. The end result is a re-lined pipe repaired from the inside.
