## Nu Flow relines at Hollard Insurance

**Customer and Site:** Hollard Insurance Company's Head Office in Park Town, Johannesburg

**Project:** Reline sewer pipes running under a section of road and beneath the security control room and boom gate.

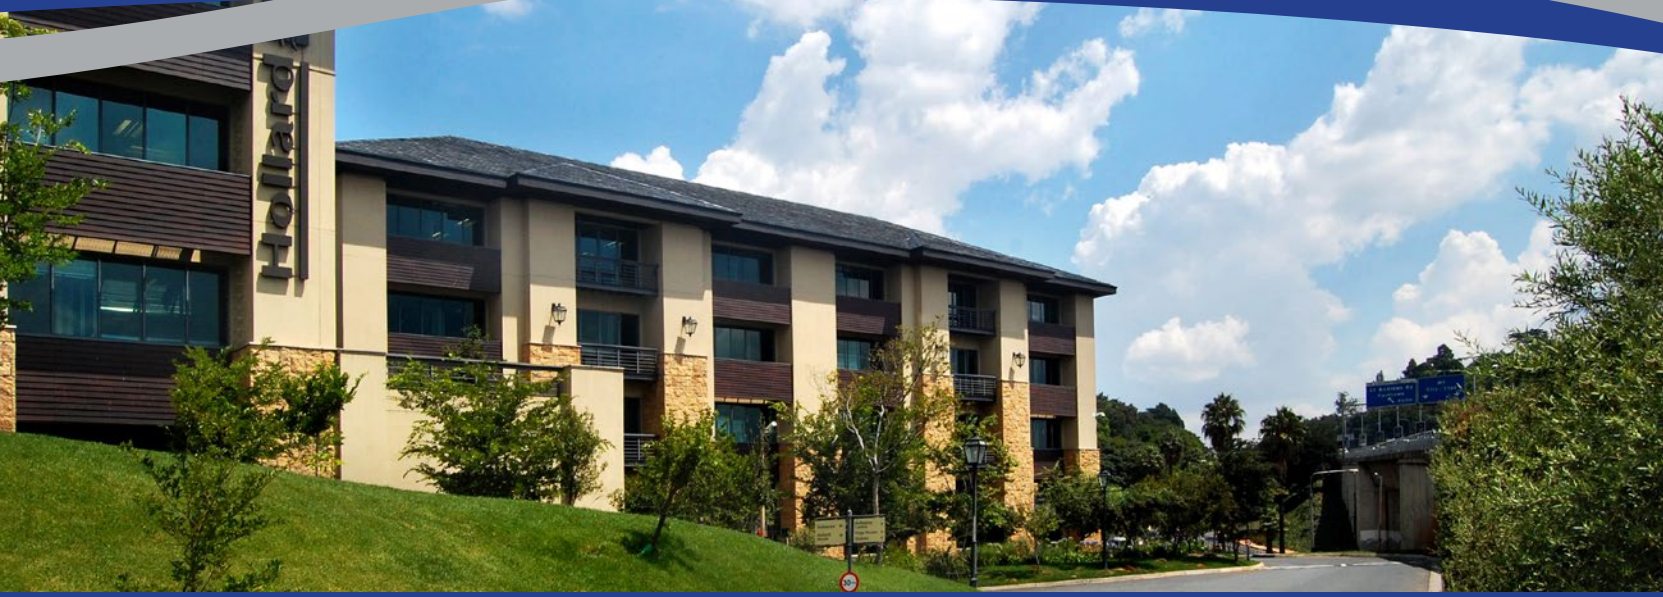
**Situation:** The pipe was badly damaged in several places. Some of the breaks in the pipe were as large as a man's fist. The worst section was a full 500mm missing section below the entry control boom.

**Solution:** Nu Flow South Africa were able to offer a cost effective and time saving solution to the client. Nu Flow relined the sewer pipe by pulling an epoxy saturated liner into the pipe from existing manholes. Once the liner is in position the bladder is inflated and the epoxy left to cure. By working from manhole to manhole the work was completed in less than a day without any digging and with minimal disruption to traffic on the site. The structural liner provided a strong new pipe inside the old damaged sewer pipe restoring proper flow.
