## Nu Flow re-lines at Kloof Village Mall

**Location:** Kloof Village Mall, Kloof, Durban

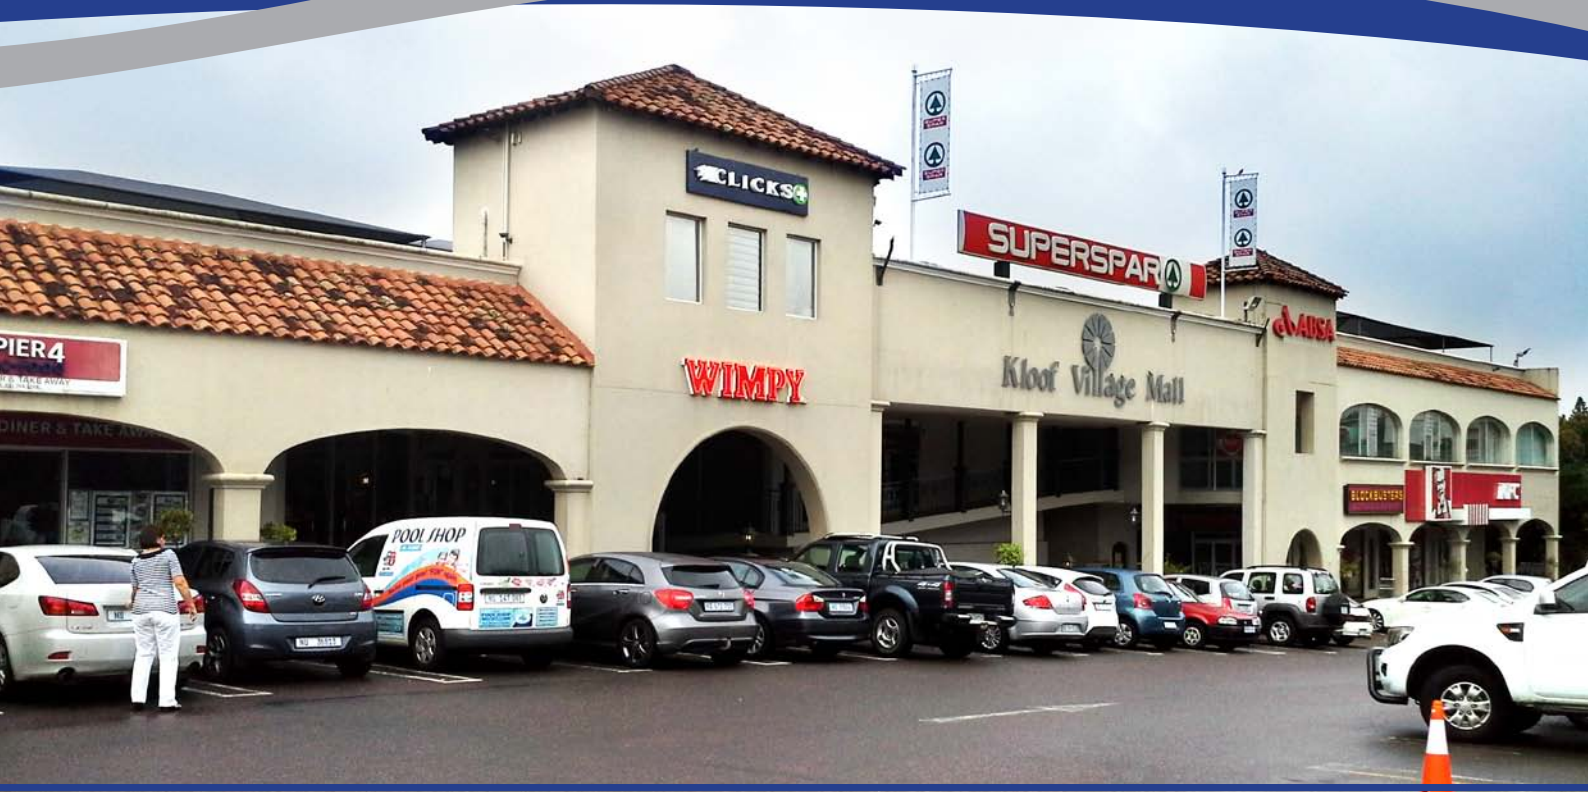
At Kloof Village Mall, whenever it rained water seeped from the 110mm PVC full bores on the roof into the coffee shop below.

The pipes had multiple displaced joints which allowed water to enter and flood the coffee shop.

Ganga Plumbers, a Nu Flow licensee, re-lined the full bores with Nu flows pull-in-place structural liner system working from existing access points thereby causing no disruption to the coffee shop nor any structural damage to the building.

The end result is a new pipe with in the old pipe. No Mess, no chopping open, no damage to structures!
