Durban Reservoir Re-Nu

Site:
Kwadabeka Reservoir, Durban

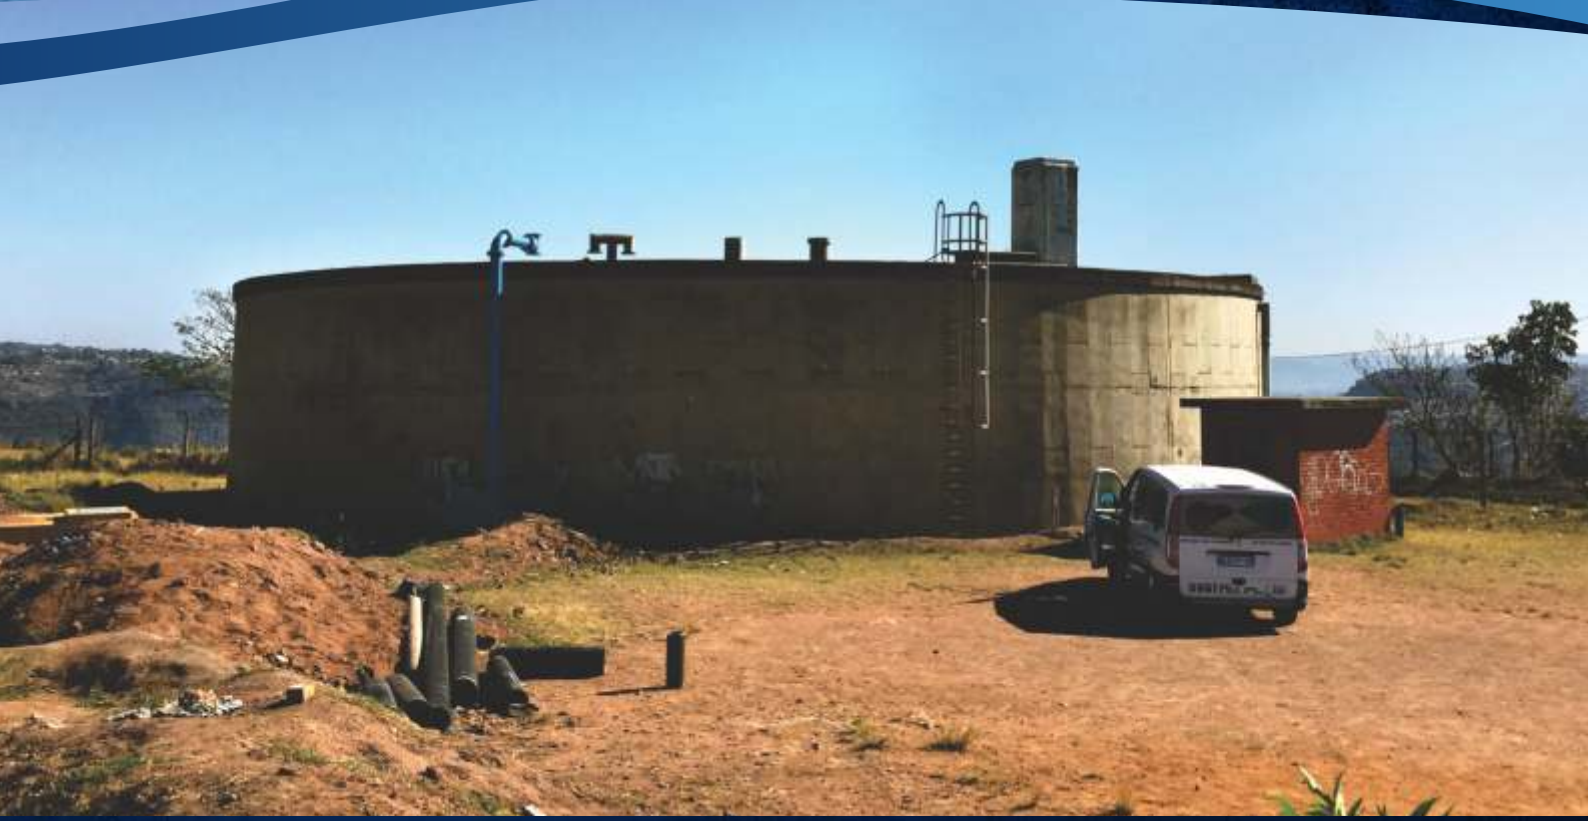
Situation:
Contractors were replacing some of the old corroded steel pipes feeding to and from Kwadabeka Reservoir.

One of the pipes in need of replacement was a 250mm steel outlet pipe which runs under the concrete floor of the reservoir to a neighbouring tank.

Solution:
Nu Flow cleaned and descaled the steel pipe using specialized cleaning equipment.

Once the pipe was cleaned, Nu Flow relined the pipe using a structural liner and Nu Flow's Red epoxy which is approved for potable water.

An epoxy saturated liner was pulled into the pipe. Within the liner is a rubber bladder which is inflated when the liner is in the correct position and is left inflated until the epoxy has cured and hardened.

The bladder is then removed leaving behind a "nu pipe" within the host pipe.
