### Nu Flow re-lines at Murray and Roberts

**Location:** Murray and Roberts, Hertzog blvd, Cape town

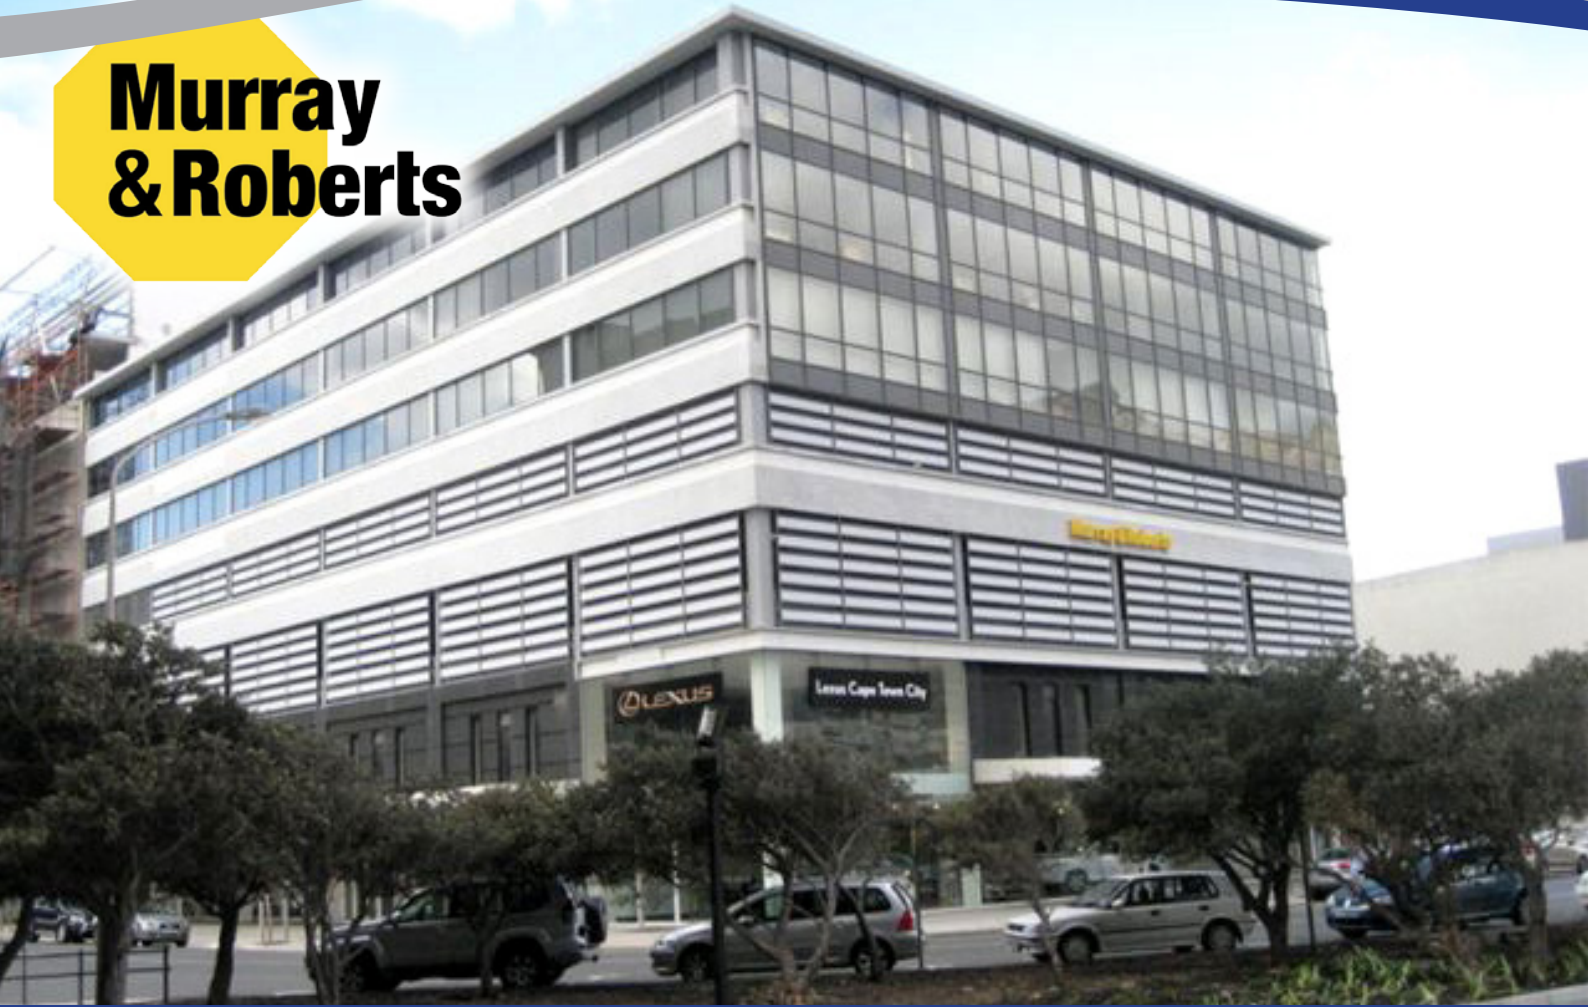
Water Damage Services' camera technicians were called to site and found a broken storm water pipe that had shifted joints allowing the water to seep into the stack.

Water Damage Services, a Nu Flow licensee used the Nu flow pull in place lining system to re-line this pipe without causing any damage to either building. Water Damage Services did in one day what would have taken traditional plumbing a week to do.

The end result is a new pipe with in the old pipe.  
No more leaks into any floors below!  
No Mess, no chopping open, damage to structures!
