## Relining on the Sa Agulhas II

**Client:** SA Agulhas II

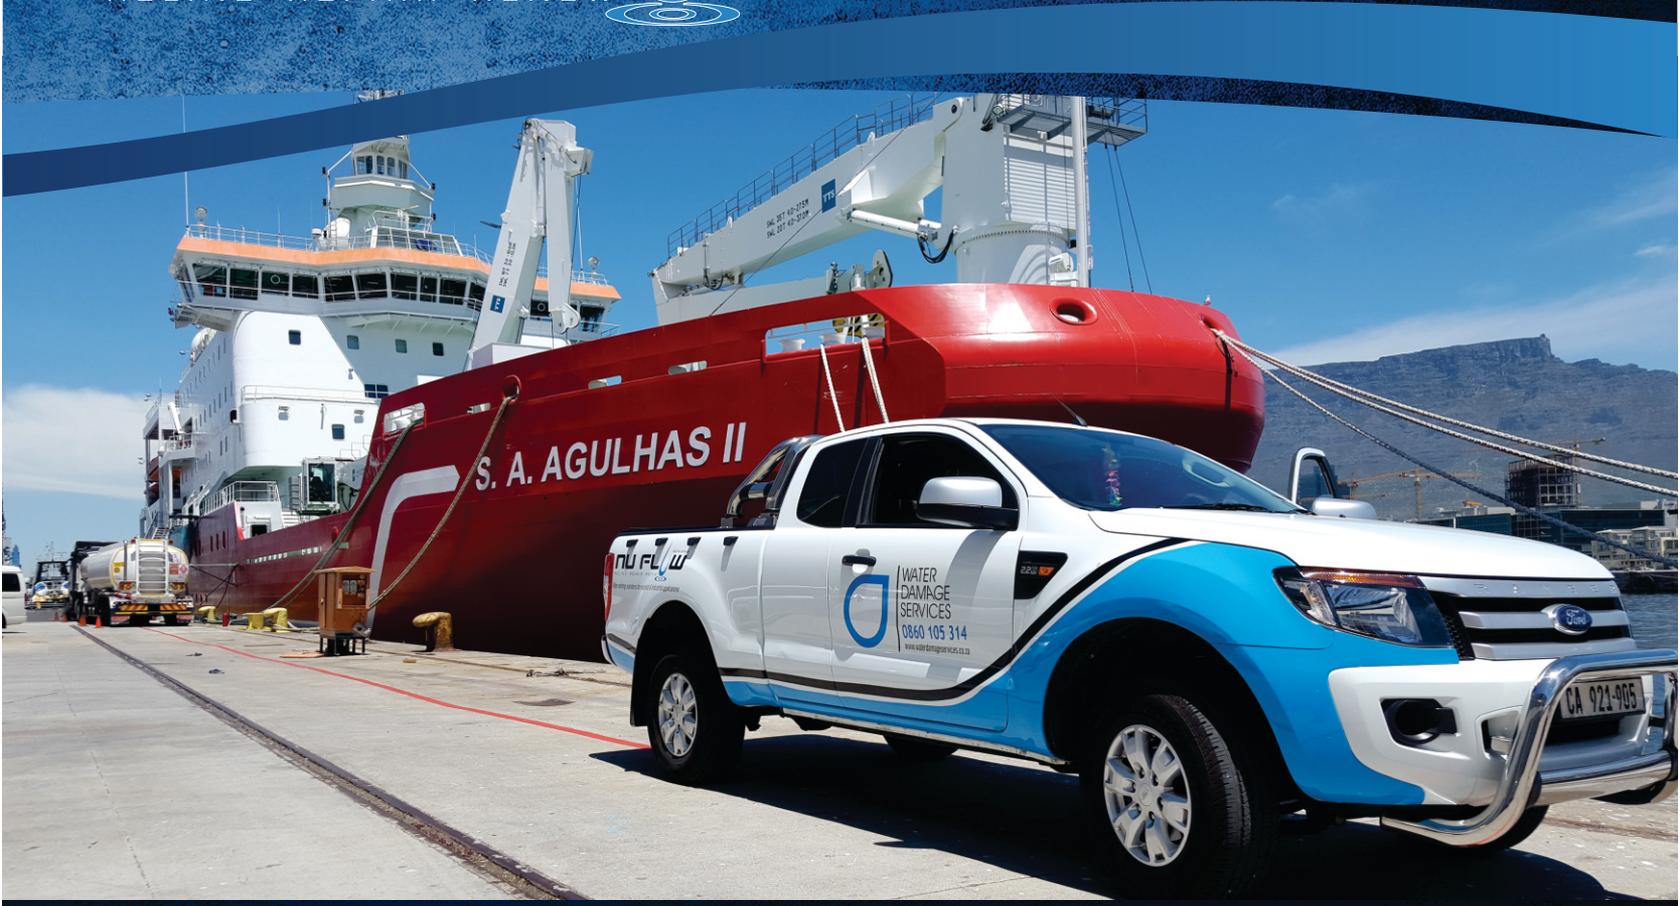
**Problem:** The sea water was leaching contaminants from the inside of the stainless steel piping and compromising the lab samples – this was a huge problem as this is a research vessel and water samples are a huge part of the expeditions, the vessel was also booked to leave port within a week of us being called out to attend to the issue.

We blew the red barrier coating though out the 50mm steel system from the engine room into the labs as well as using the red potable epoxy in a structural liner to line the main 160mm pumping line from the hull.
