## Nu Flow re-lines at De Waterkant Piazza Body Corporate

**Location:** De Waterkant Piazza, De Waterkant, Western Cape

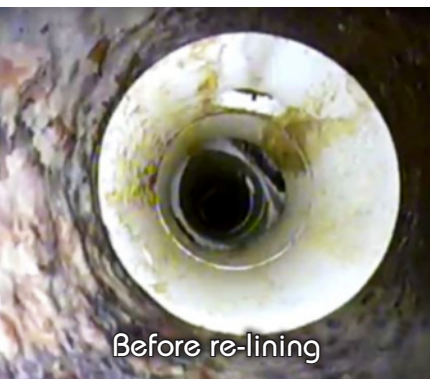
Nu Flow were called to site to investi-gate a PVC sewerage pipe that had been join onto a cast iron stack.

The fact that there is no glue that can bond these two materials was allowing the water to seep into the stack.

Before re-lining

Nu Flow re-lined the space between these two pipe with Nu Flow's pull-in-place structural lining system creating a smooth free flowing pipe.

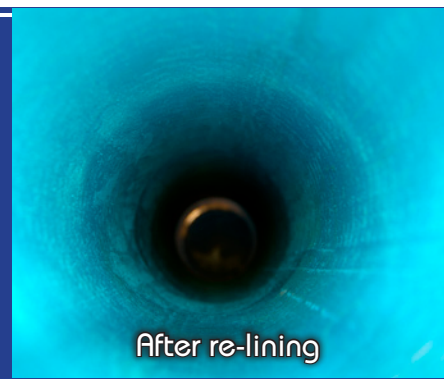
The end result is a new pipe within the old pipe. NO mess, NO chopping open, NO damage to structures!

After re-lining

The re-lining was done working from existing access points thereby causing no damage or distruction to the building.
