## Nu Flow re-lines one of Steer & Co's Buildings in Tamboerskloof

**Location:** Warren road, Tamboerskloof, Cape Town, Western Cape, South Africa

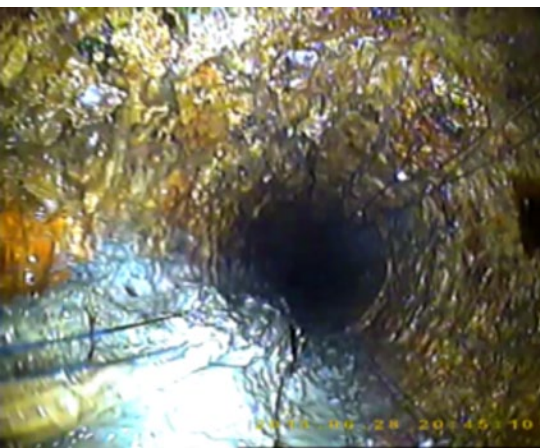
### **Are you concerned about elbows & tees in pipes?**

Nu Flow re-lining process can effortlessly get around 90 degree bends!

Nu Flow used Nu Flow's pull-in-place structural re-lining system to re-line the inside of the pipes working from existing access points thereby causing no damage to the structural integrity of the building.

**NO Damage! NO noise! NO Mess!**  
The end result is a new pipe within the old pipe.
